AIR QUALITY ASSESSMENT  
THUNDER BAY TERMINALS LIMITED  
THUNDER BAY  
1980

TECHNICAL SUPPORT SECTION  
NORTHWESTERN REGION  
ONTARIO MINISTRY OF THE ENVIRONMENT  
June, 1981

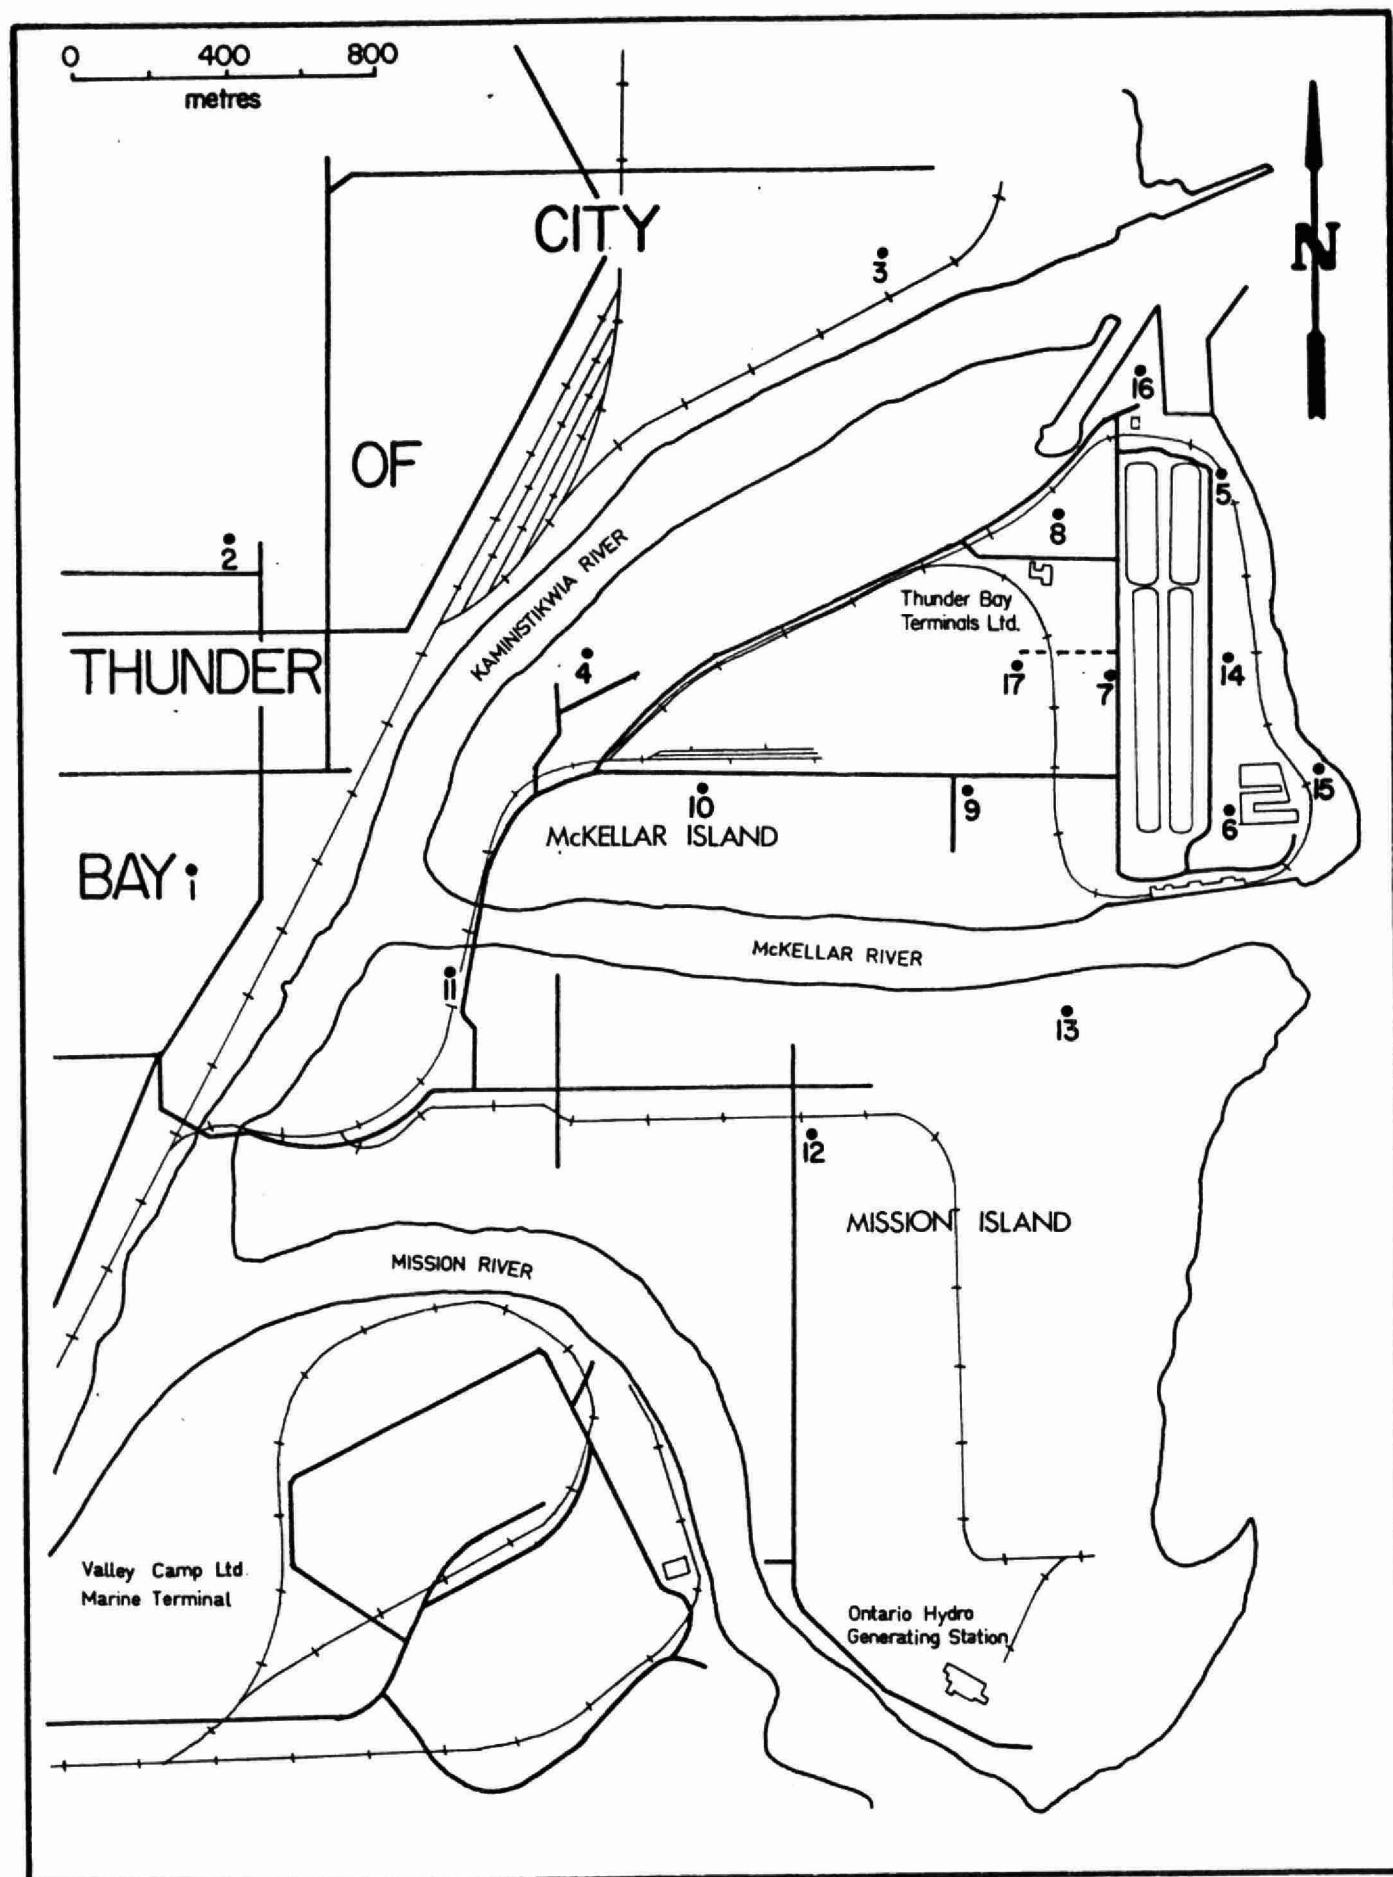
Figure 1. Snow sampling sites, February 28, 1980.

Duplicate samples of snow were collected on February 28, 1980, from 17 sites near the Thunder Bay Terminals Ltd. coal piles (Figure 1), and from two control locations remote from the source under investigation. A detailed description of the sampling method appeared in a previous report (6). Snow melt-water collected from each site was measured for pH and conductivity, and analyzed for aluminum, arsenic, carbon and iron.

Coarse and fine coal particles were conspicuous in snow at sites 5, 6, 7, 8, 9, 12, 14, 15, 16, and 17. Heavy deposition of this material was observed near the coal piles, with decreasing amounts up to a distance of approximately 350 m (metres).

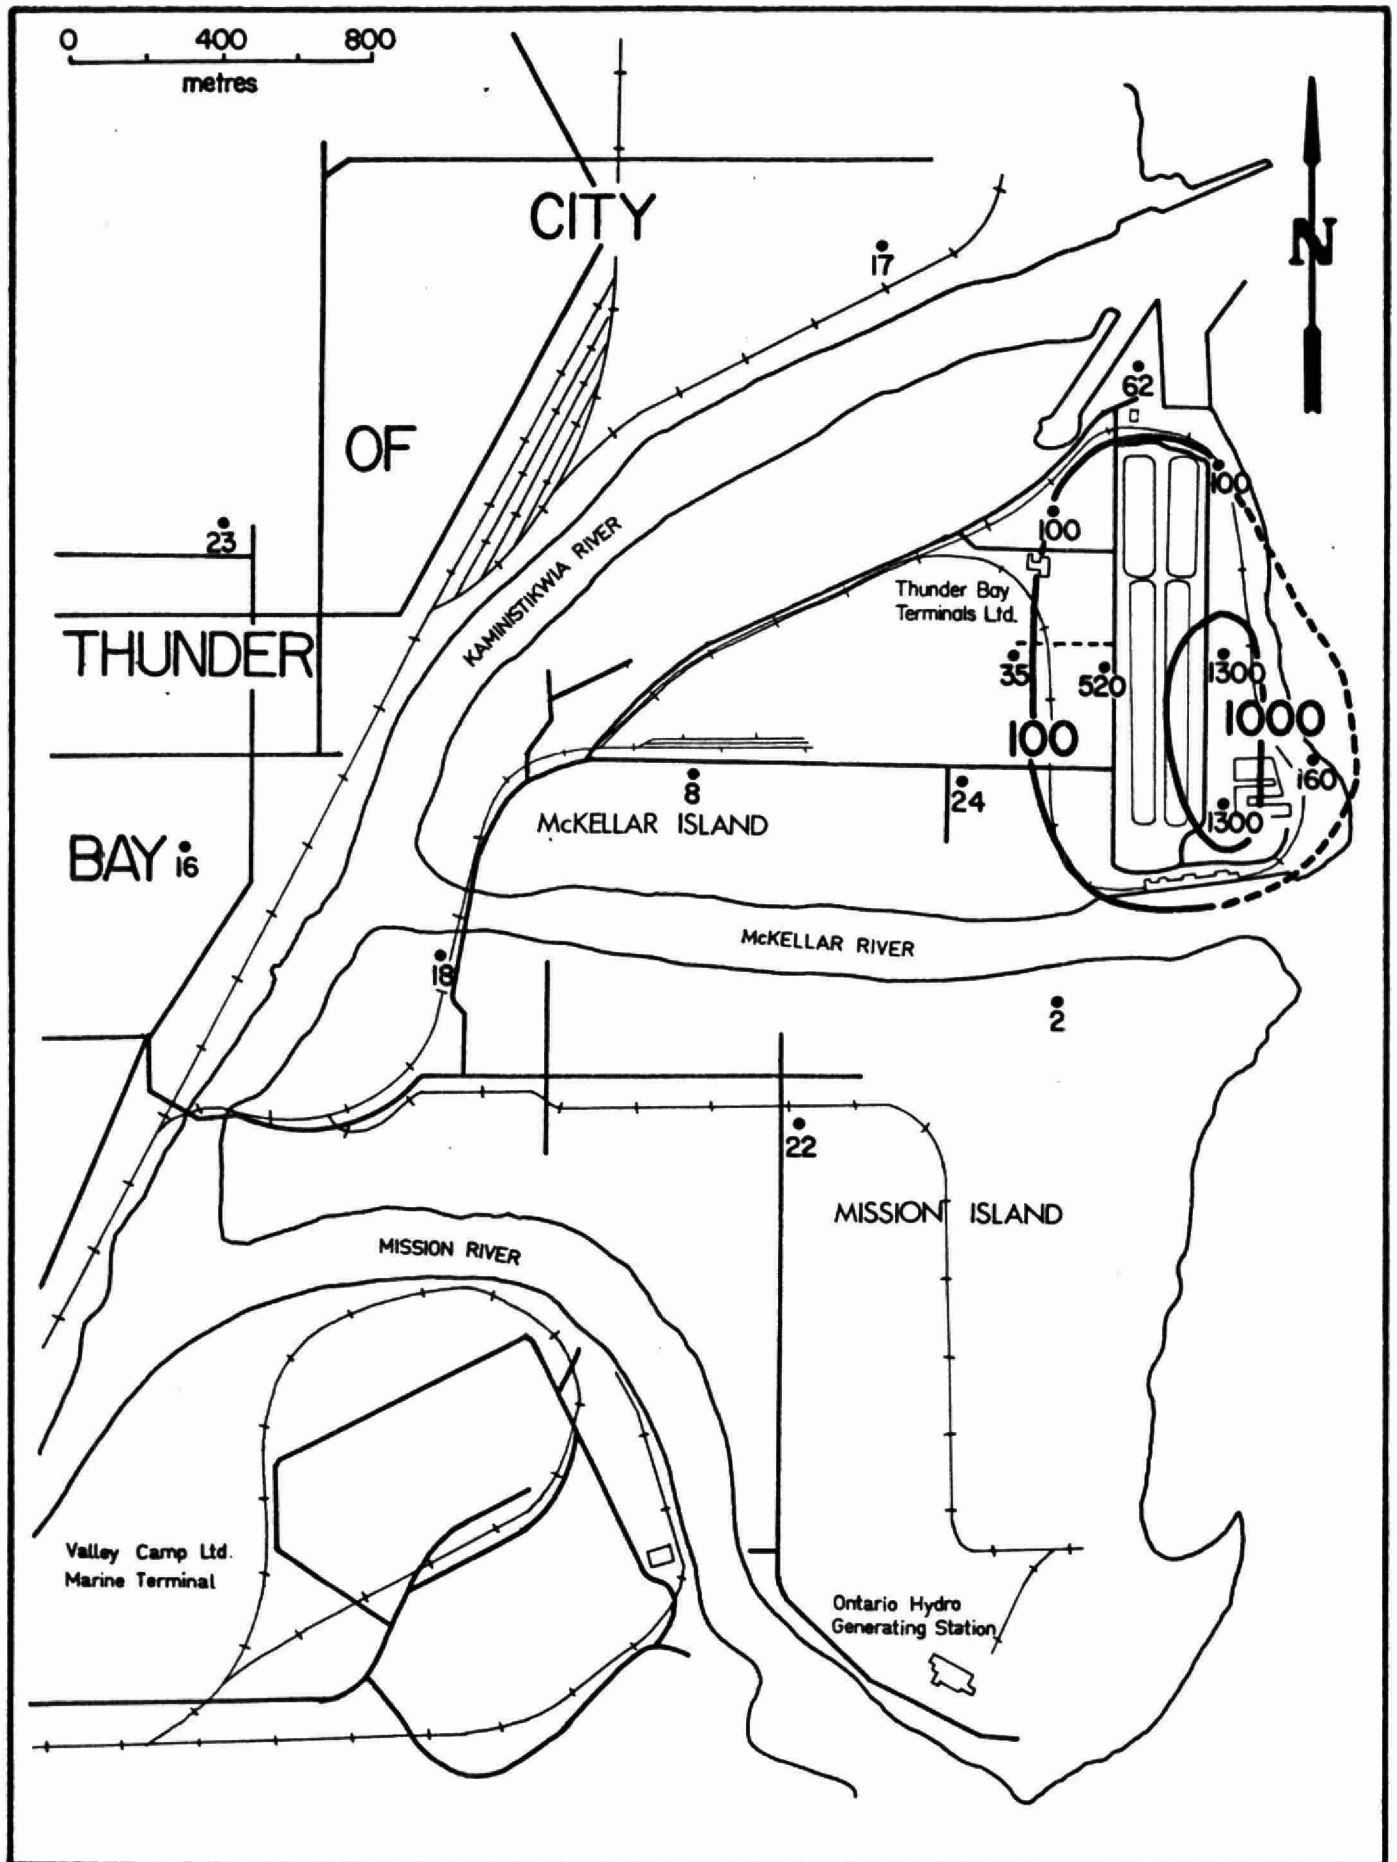
Figure 2. Levels of total carbon (mg/l) in snow, February 28, 1980.

increasing distance from this zone. The distribution pattern for total carbon, shown in Figure 2, was similar to that for aluminum, iron, suspended solids and pH.

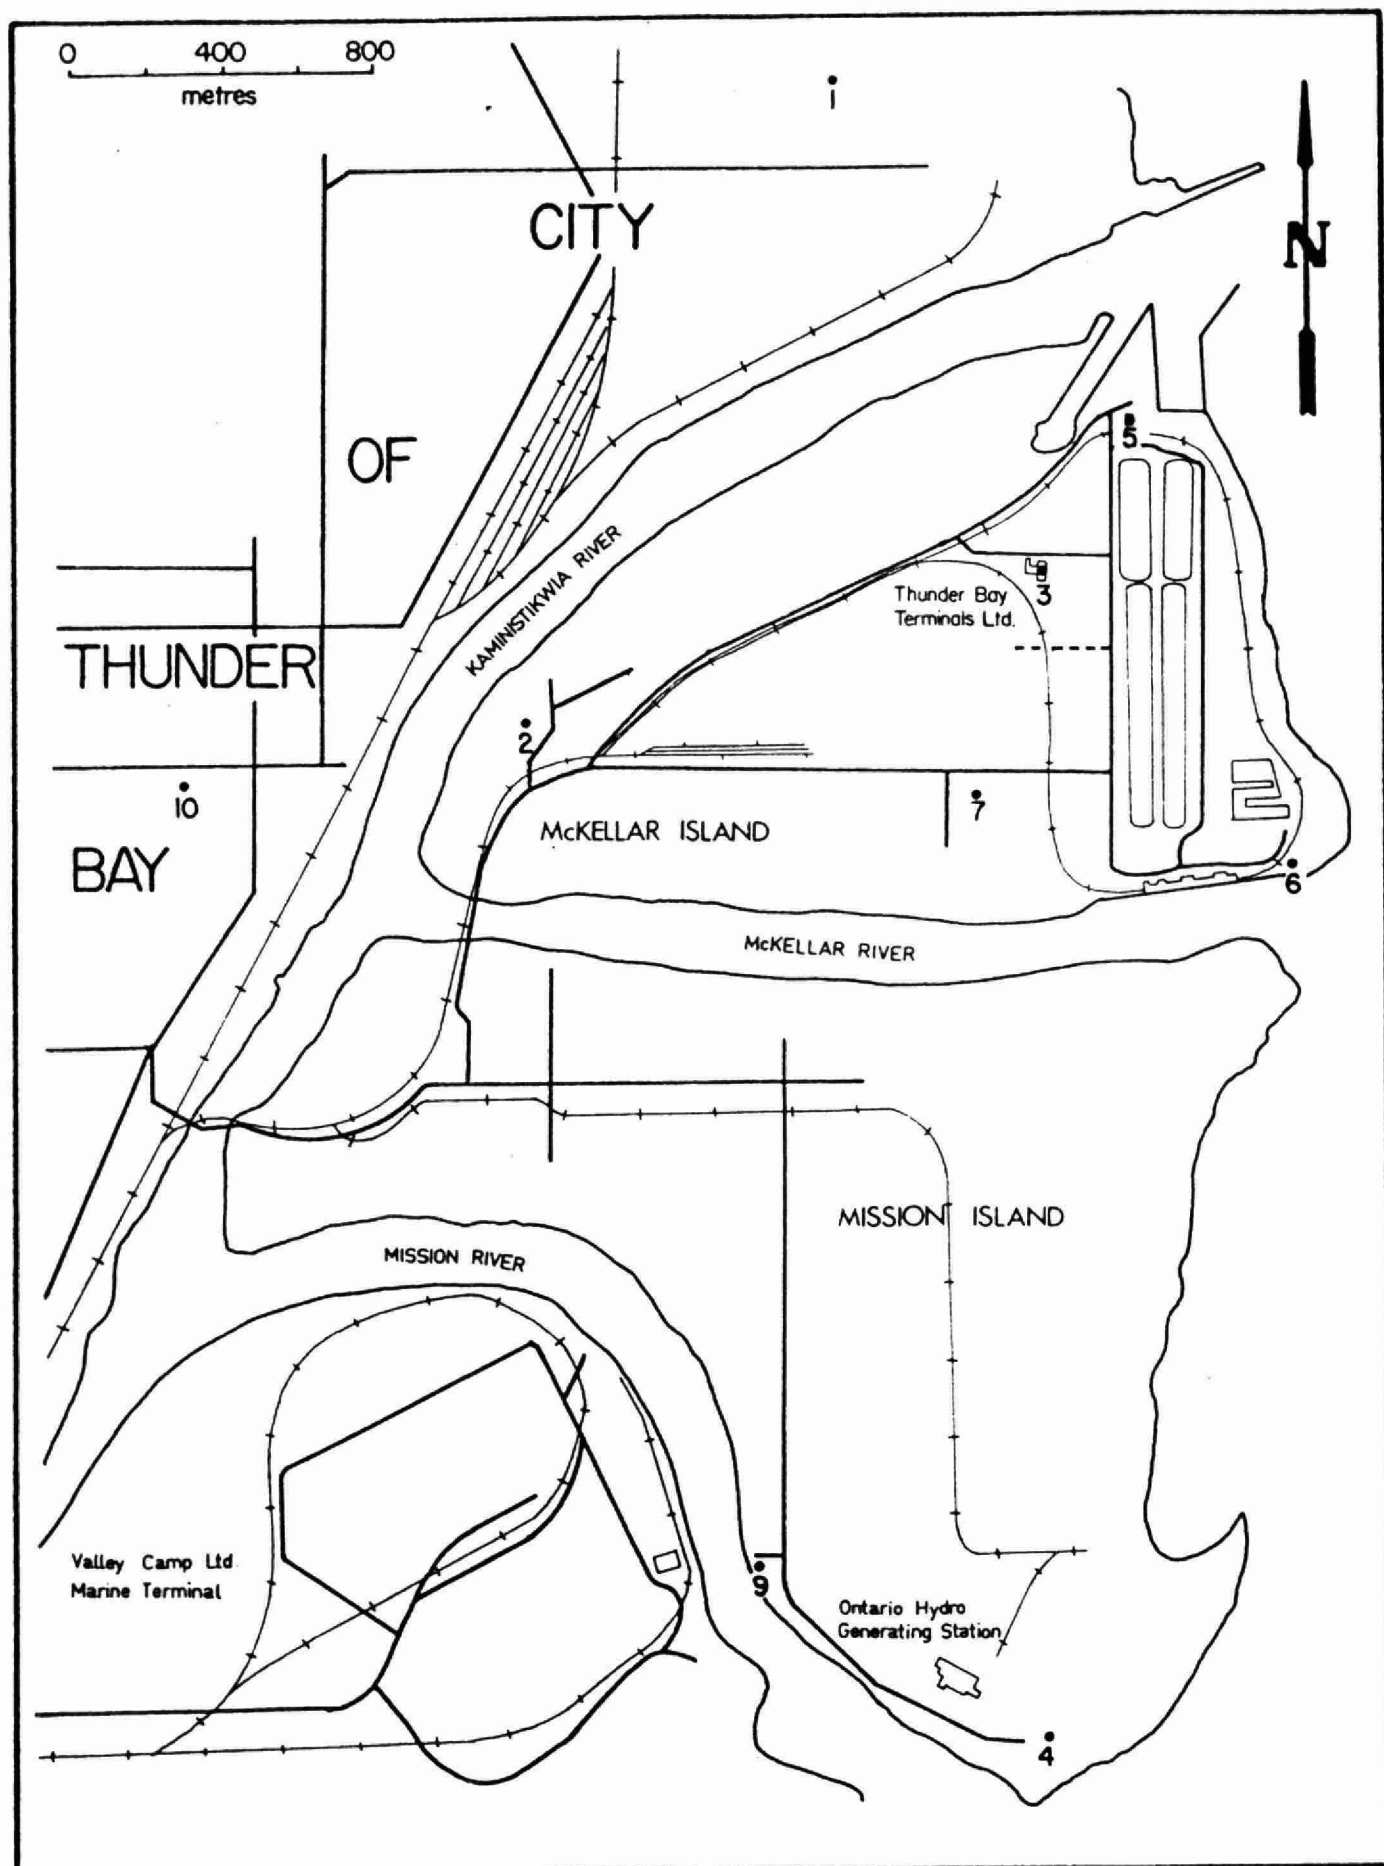
Figure 3. Air quality monitoring sites, 1980.

Dustfall, comprising particulate matter which settles out from the air by gravity, was measured at the sites shown in Figure 3. Seven of the nine monitoring locations belonged to a network operated by V. B. Cook Company Limited, project managers for Thunder Bay Terminals Limited. Sites 9 (Kam Boating Club) and 10 (McKellar Hospital) were part of the Ministry of the Environment air quality monitoring network for Thunder Bay. A description of the dustfall measurement method appears in the report for 1977 (4).

Dustfall levels for 1980 are presented in Table 2. Except for one month at one site (August, Shell Oil Terminal), monthly and average annual dustfall complied with Ontario objectives at all locations off Thunder Bay Terminals and Ontario Hydro property.
